In-vivo damage development in Vena Cava Filter: Study of a retrieved device

Abstract: This article was prepared from a project assigned in a graduate class, BME 7371, Failure Assessment of Medical Devices, taught at Wright State University by the senior author. The device was donated for the study which was successfully retrieved after 93 days *in-vivo*. Even-though the mechanical integrity of the device held in-tact, the microscopic observations revealed that the damage via corrosion and scratching took place on the surface of the device. The image reconstructed in 3D using image-J software to determine device roughness and depth-of-pits. Results presented in this paper show that damage starts developing in these devices after the implantation that resulted in premature failure in many cases as reported in the media and literature.

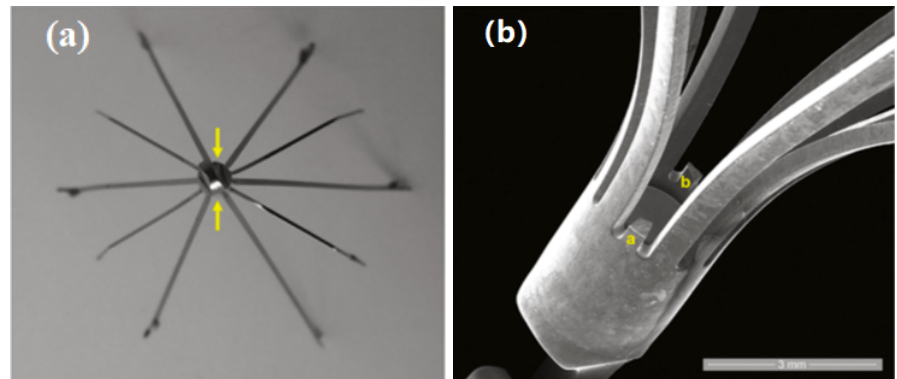
In a previous study, a 46-year-old woman came in for her 6 month check-up and complained of chest pains. Radiography revealed two fractured components that were identified [7]; one stuck in the pulmonary wall was retrieved successfully and the other in her right ventricle which required an open heart surgery. The failed device showed metal fatigue as the cause of the failure. The patient had morbid obesity (BMI 58.88 kg/m²), had undergone gastric bypass surgery. The filter was implanted before to make sure no thrombosis were present even though the patient had no family history of thrombosis. Below is a picture of the missing arms. (see Figure 4)

Figure 4 (a) Missing arms in case study, both medium arms broken at the bottom of hook/apex of device, and (b) scanning electron micrograph showing higher magnification [7].

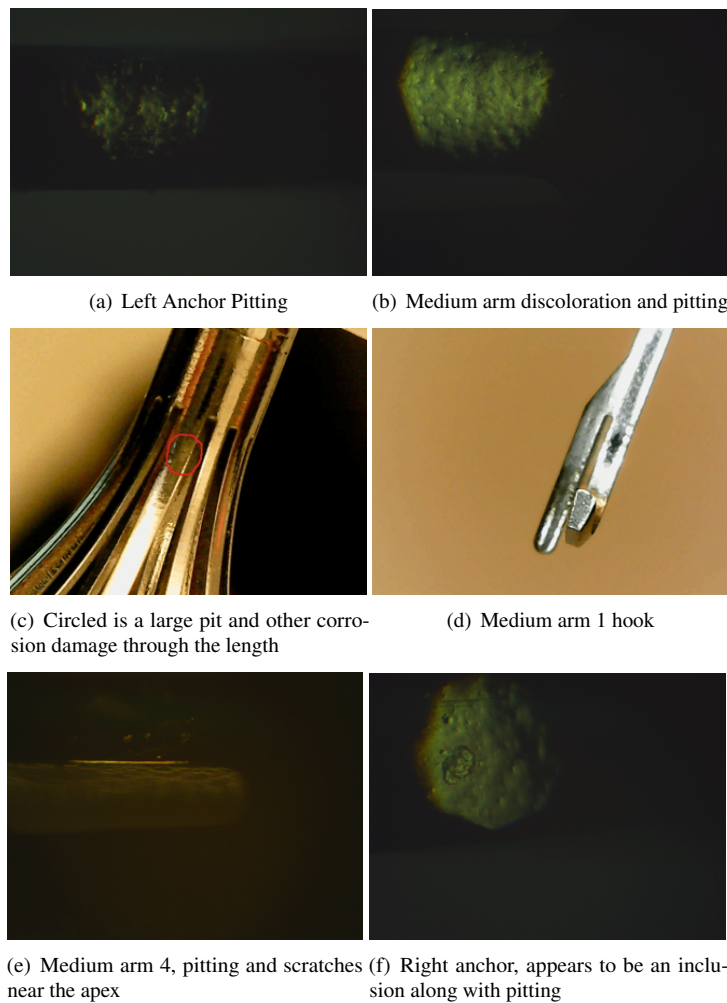
to study that area for each tine. Below are images that were taken using the optical microscope. Even though it was very difficult to position the device in the microscope to document damage development, we observed that each tine was damaged, where pitting and scratching observed. We chose to present select few tines showing these damages in Figure 5 and 6, respectively. Device was *in vivo* for 93 days and each tine exposed to uniform conditions. Since we do not know of the pitting kinetics and other conditions, we will not discuss the growth rates therefore, the features identified are presented. All the regions in the filter, immediately below the hook showed pitting and scratching taking place. It is likely that machining those edges may have left residual stresses and may be speculated to have thermal distortion, together with inclusions resulted in pitting corrosion. Since the device is positioned in the blood flow direction and those contacts are showing to be eroding the filter tine surfaces. As a result the scratches generate. Since the depth of the pitting is higher than those of scratches, it is likely that pit, upon reaching a critical size, may transition to fatigue. An aspect ratio of 1 was connected to be a transition criterion [10], thus corrosion fatigue may be concluded for the failed tines.

Figure 5 Microstructural details of the damage in various locations of the filter

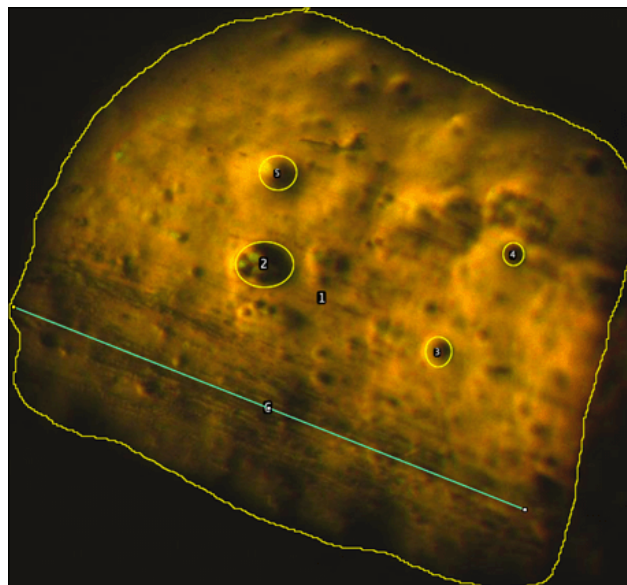
We developed a method to further process the images presented above in Figure 6. Image was analyzed using Image-J, the area of the lighted portion, in terms of the mean, min, and max. It is possible to determine how many pits are in the material, and how deep the pits are. This analysis is at one spot at the small arm 6 near the apex.

Figure 7 Image of small arm 6, with labeling of scratches and pits

No.	Label	Area	Mean	Min	Max	Angle	% Area	Length
1	SA6 Large pit.jpg	241293	67.88	21	163	0	0	0
2	SA6 Large pit.jpg	1940	55.96	24	155	0	0	0
3	SA6 Large pit.jpg	577	83.99	31	142	0	0	0
4	SA6 Large pit.jpg	344	52.8	28	96	0	0	0
5	SA6 Large pit.jpg	928	80.96	30	163	0	0	0
6	SA6 Large pit.jpg	533	47.82	27.33	78.3	-21.6	0	532.4

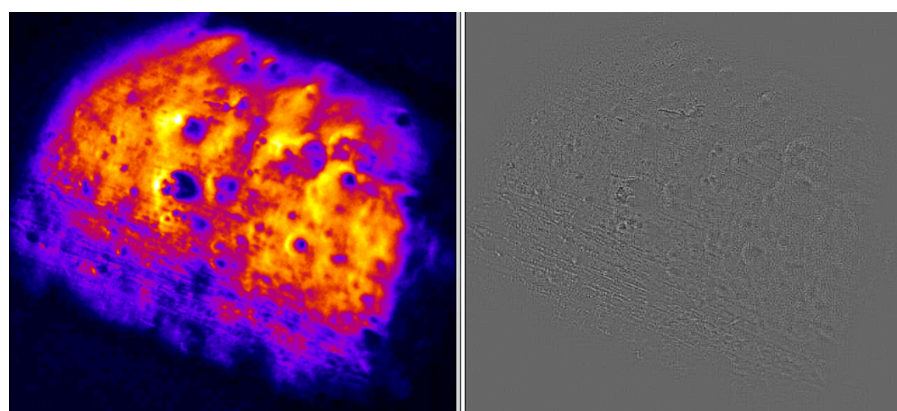
Slice	Rq	Ra	Rsk	Rku	Rv	Rp	Rt	Rc	FPO	MFOV	FAD	MRV	SA
1	30.63	26.28	0.85	-0.41	19.67	163.33	143.67	50.42	40.32	31.96	57.23	0.02	2.21

Figure 8 Waviness and Surface Roughness at the same location, small arm 6.

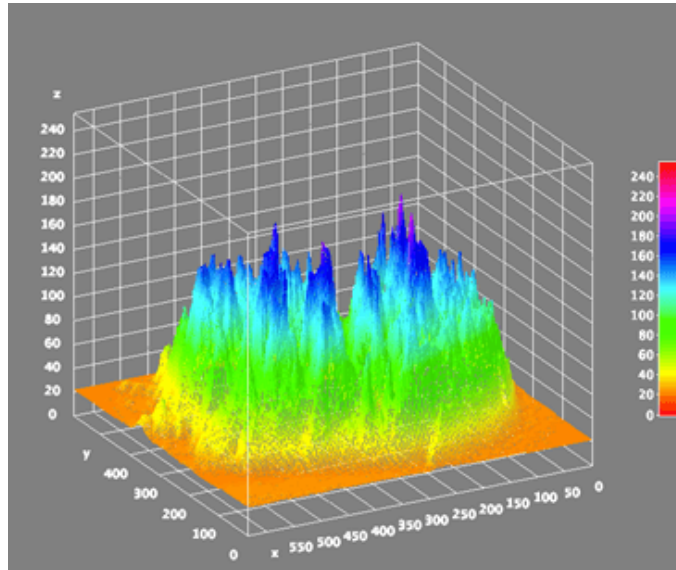
Figure 9 Surface plot of the Images above, the pitting is shown through the depth

Since the Ra is the measure of surface peaks and valleys, it is the arithmetic average of the height deviation in the profile shown in [Table 4](#) and [6](#) is 26. Even though the bacterial infection on these devices found to be rare in literature, if the roughness increases a certain value, those bacterial sites can find a foothold in those locations. [Figure 9](#) and [11](#) show the 3D plot of the pits, it is apparent the depth of the pits exceeded 150-240 μm . From the limited information that we have on the device, we cannot isolate if an increase in application temperature, from 30 to 37°C caused the material to creep. Cavitation is one of the ways the damage develops under creep conditions and may be manifested in terms of the pits. Both pitting corrosion and creep cavitation are uniformly distributed damage, it is likely that their interactions produced more damage as documented in [Figure 9](#) and [11](#).

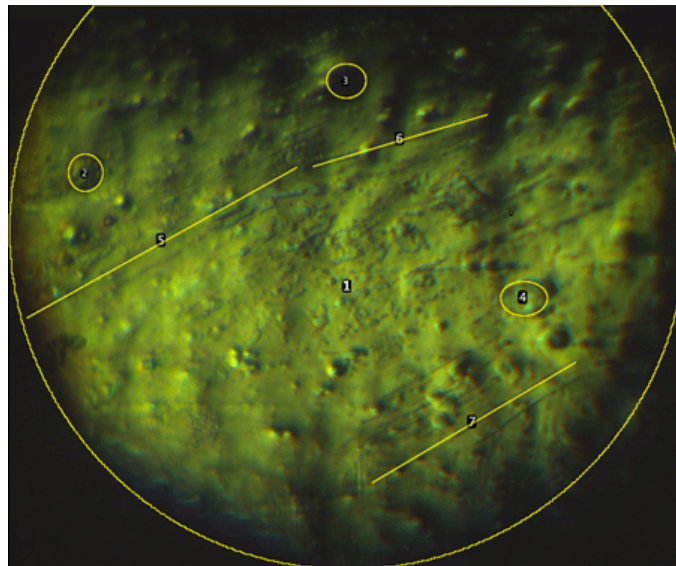
Figure 10 Image of Analysis of Medium Arm 4

No.	Label	Area	Mean	Min	Max	Angle	% Area	Length
1	Medium arm 4 Scratch/pit	530202	64.7	24	188	0	0	0
2	Medium arm 4 Scratch/pit	1700	53.2	37	86	0	0	0
3	Medium arm 4 Scratch/pit	1803	34.9	28	76	0	0	0
4	Medium arm 4 Scratch/pit	2120	86.76	48	140	0	0	0
5	Medium arm 4 Scratch/pit	398	73.83	29.26	109	29	0	396.9
6	Medium arm 4 Scratch/pit	235	63.38	35.37	138.24	16.65	0	233.71
7	Medium arm 4 Scratch/pit	305	67.21	39.89	102.18	30.44	0	303.67

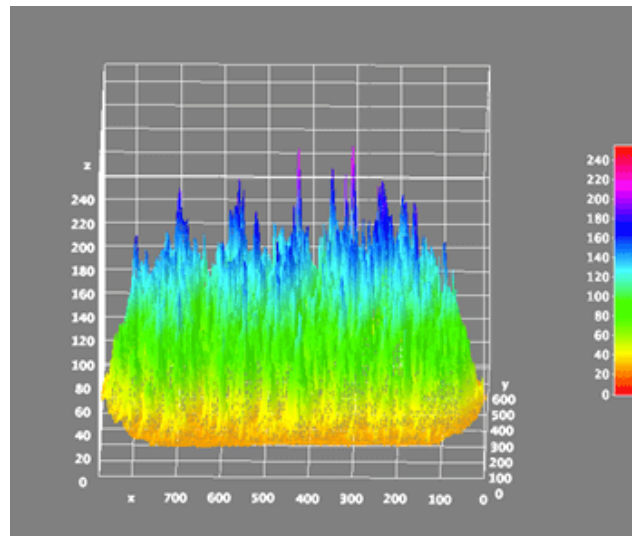
Figure 11 Surface plot of the image in [Figure 10](#)

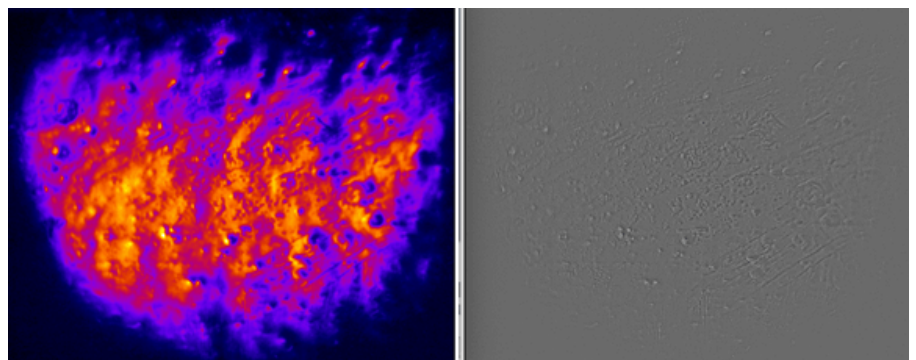
Slice	Rq	Ra	Rsk	Rku	Rv	Rp	Rt	Rc	FPO	MFOV	FAD	MRV	SA
1	28.36	24.52	0.56	-0.77	23	187.67	164.67	58.85	47.49	25.56	152.49	0.048	2.17

Figure 12 Waviness and Roughness using Image-J plug-in
