In-vivo damage development in Vena Cava Filter: Study of a retrieved device

Abstract: This article was prepared from a project assigned in a graduate class, BME 7371, Failure Assessment of Medical Devices, taught at Wright State University by the senior author. The device was donated for the study which was successfully retrieved after 93 days *in-vivo*. Even-though the mechanical integrity of the device held in-tact, the microscopic observations revealed that the damage via corrosion and scratching took place on the surface of the device. The image reconstructed in 3D using image-J software to determine device roughness and depth-of-pits. Results presented in this paper show that damage starts developing in these devices after the implantation that resulted in premature failure in many cases as reported in the media and literature.

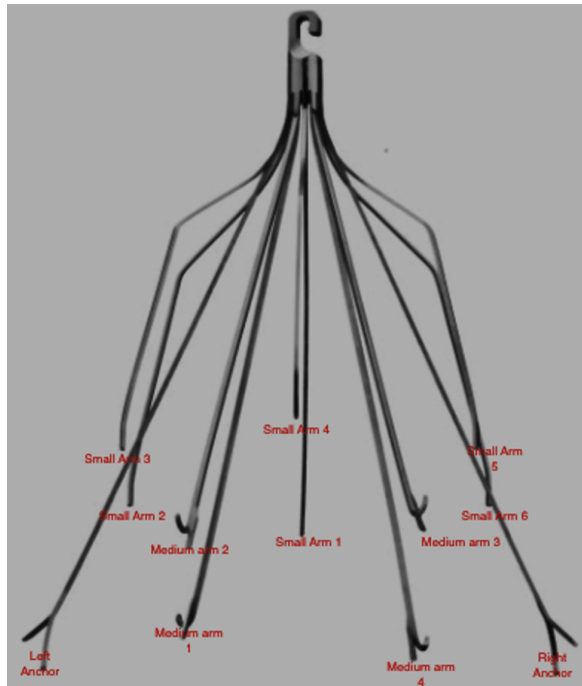
Figure 3 Device analyzed together with labeling of the hook, tines, and anchor.

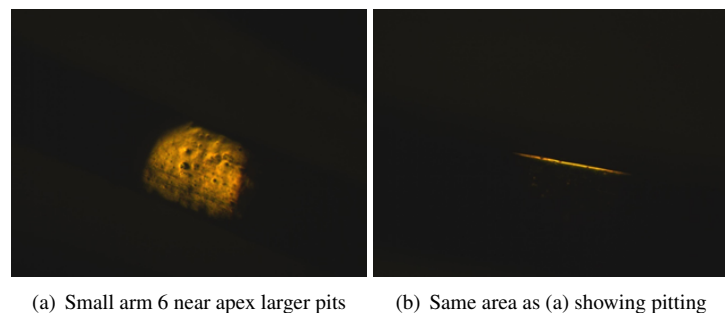
Figure 6 Identifying area for further analysis and method development

We developed a method to further process the images presented above in Figure 6. Image was analyzed using Image-J, the area of the lighted portion, in terms of the mean, min, and max. It is possible to determine how many pits are in the material, and how deep the pits are. This analysis is at one spot at the small arm 6 near the apex.
