## RESEARCH ARTICLE

## Safe zones in hip-implant designs to resist dislocation

**Citation:** Bhatt H and Goswami T. Safe zones in hip-implant designs to resist dislocation. *Res Intell Manuf Assem*, 2022, 1(1): 20-27.  
<https://doi.org/10.25082/RIMA.2022.01.003>

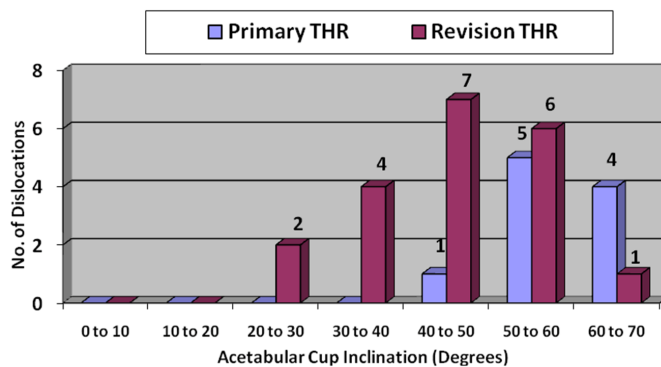
As shown in Figure 1, among all total hip dislocations, 90% of the cases evaluated with 50° or more inclination angle with horizontal axis for acetabular component [15]. Subsequently, 35% of these cases examined were with the revision dislocations. The cup inclinations showed higher rate of failure for 20 to 60°. Above 60° of cup inclination, the dislocations found were less frequently occurring than the primary dislocations. The recommended vertical inclination of cup was 40 to 40±10° and anteversion 15±10° [8].

**Figure 1** Acetabular Cup Inclinations in Primary and Revision THRs, amongst all total hip dislocations, 90% of the cases were evaluated with 50 degrees or more inclination angle with horizontal axis for acetabular component [13].

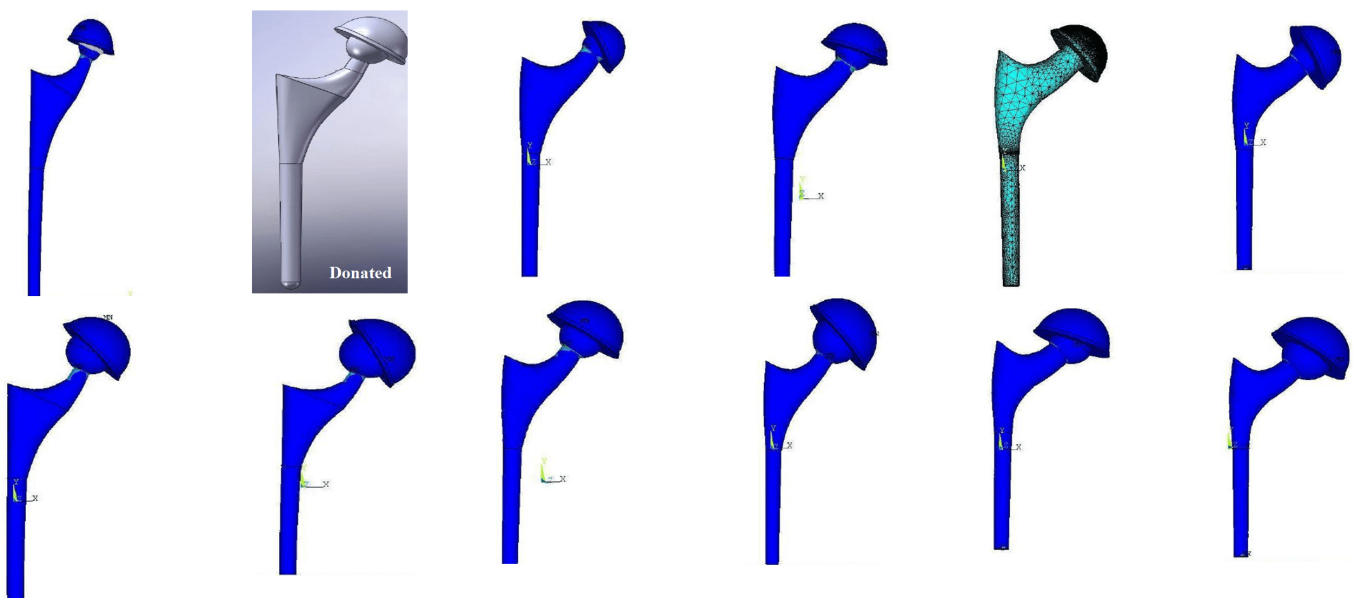
SolidWorks 2008 SP 2.1 was used to create the hip implant models. The design details, geometrical parameters for each of the implants are summarized in Figure 2 and Table 3. One of the implants was donated by TRIDENT™ acetabular System by Stryker Howmedica, Osteonics. ANSYS 11.0 was used to create solid models, mesh and stress analysis. All implants were analyzed using the material properties of stainless steel, SS 316L. The properties inserted were Young’s modulus 209 GPa, Poisson’s ratio, 0.3, and density of the material, 7800 kg/m<sup>3</sup>. Results from the finite element analysis were used to develop safe design estimates, those combinations of parameters were entered in zone, called safe zone. The following sections perform the analysis of safe zones for all the 12 implants. The implant geometrical dimensions within these zones provide dislocation resistant implants and considered to be most safe.

**Figure 2** Hip implant designs used in the research

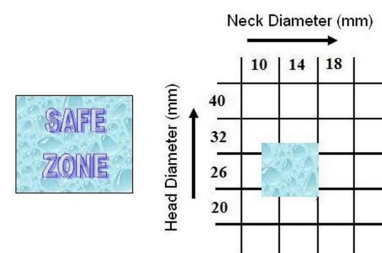
Several combinations of head and neck diameters were evaluated to define a safe zone in order to reduce the risk of dislocation. Figure 3 shows safe zone for all combinations of head and neck diameters. Head diameter below 26 mm and above 32 mm was examined particularly for higher risk of hip instability. Neck diameters above 10 mm as well as below 18 mm showed lowest von Mises stress. The optimum performance was for neck diameter of 14 mm.

**Figure 3** Safe zone for combinations of different head diameters and neck diameters, head diameter below 26 mm and above 32 mm was examined with higher risk of hip instability.

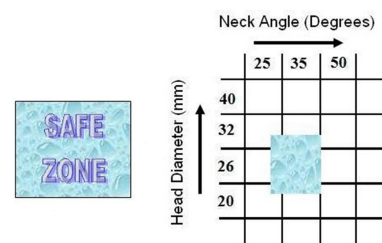
A similar safe zone was examined for combinations of head diameters and neck angles (Figure 4). The safe range for head diameters were from 26 mm to 32 mm. The range of examination for neck angle was from 25 to 50° from vertical axis. The safe zone was considered as neck angle between 25 to 35°. The best combination of both design parameters was evaluated as 26 mm of head diameter and 35° of neck angle.

**Figure 4** Safe zone for combinations of different head diameters and neck angles. Safe zone was considered as head diameters from 26 mm to 32 mm, and neck angles between 25 to 35°.

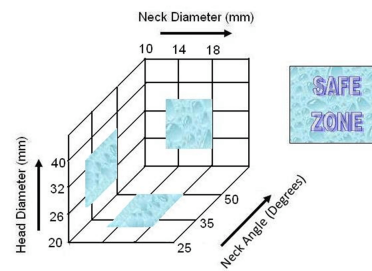
An analysis of ranges of head diameters, neck diameters and neck angles was used to define a safe area which included all three design parameter at the same time. Figure 5 shows the safe zone for all three selected parameters. Head diameters between 26 mm to 32 mm, neck

diameters closer to 14 mm, and neck angle between 25 to 35° were examined to be the safest ranges for hip implant designs.

**Figure 5** Safe zone for combinations of different head diameters, neck diameters and neck angles, head diameters between 26 mm to 32 mm, neck diameters between closer to 14 mm, and neck angle between 25 to 35° were examined to be safest ranges for individual performances of these parameters.

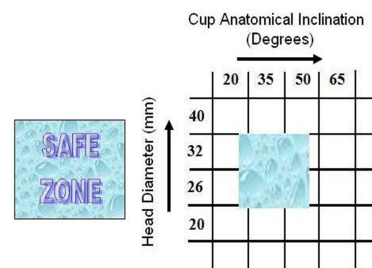
Anatomical orientations of acetabular components were examined to reduce the occurrence of dislocation due to improper fixation angles. Cup anatomical inclination was found to be a significant factor affecting hip stability. Proper inclination of acetabular cup is believed to provide suitable holding of femoral head within the cup socket. Figure 6 defines a safe zone for all combinations of head diameters and cup anatomical inclinations. The head diameters between 26 mm to 32 mm were defined as secured region for femoral head designs. A selected range for evaluation of cup anatomical inclination was from 20 to 65° from horizontal axis. The risk area was examined for cup inclinations below 35° as well as above 50°; while, safe zone was described as cup inclination between 35 and 50°. A study by McCollum and Gray [29] determined similar safe range of 30 to 50° for cup inclination.

**Figure 6** Safe zone for combinations of different head diameters and cup anatomical inclinations, the head diameters between 26 mm to 32 mm were defined as secured region for femoral head designs. The risk area was examined for cup inclinations below 35 as well as above 50°, while, safe zone was described as cup inclination between 35 and 50°.

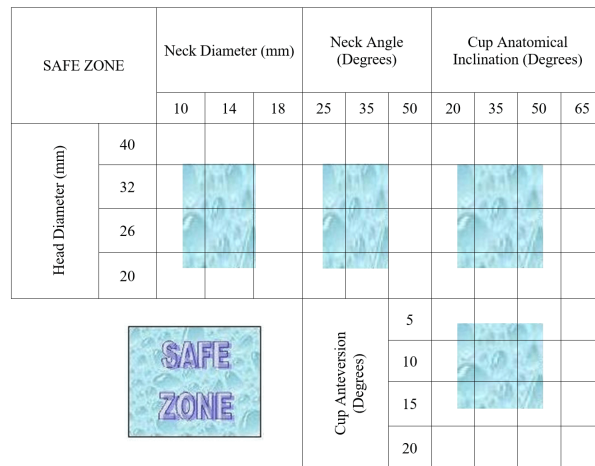
Similar study by Scifert et al. [30] showed 47.6 MPa of von Mises stresses for 60° of cup inclination with 25° of cup anteversion compared to 44.25 MPa of von Mises stresses for 45° of cup inclination and 15° of cup anteversion. Figure 8 was developed to combine the safe areas observed for combinations of hip implant design and non-design related parameters used in this study.

**Figure 8** Safe Zones for combinations of hip design and non-design related parameters. For head diameters from 26 mm to 32 mm, neck diameters closer to 14 mm and below 18 mm, neck angles between 25 to 35°, cup anatomical inclination from 35 to 50° and cup anteversion below 20° were found within safe ranges for a stable hip implant design.
